Division of Waste Management Solid Waste Section

Date of Site Inspection: February 14, 2012 Date of Last Inspection: September 16, 2010

City of Durham Transfer Facility 2115 East Club Boulevard Durham, NC 27704

Comprehensive Audit

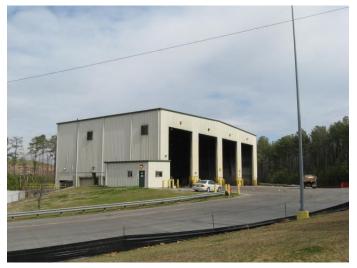
- 23. The transfer station building appeared to be in good repair.
- 24. Mr. Jarboe stated that the tipping floor and load-out area are cleaned daily. The facility is in the process of power washing the transfer station walls, although the water hose is broken. Ensure that the water hose is repaired and that the transfer station is periodically power washed.

Transfer station building
